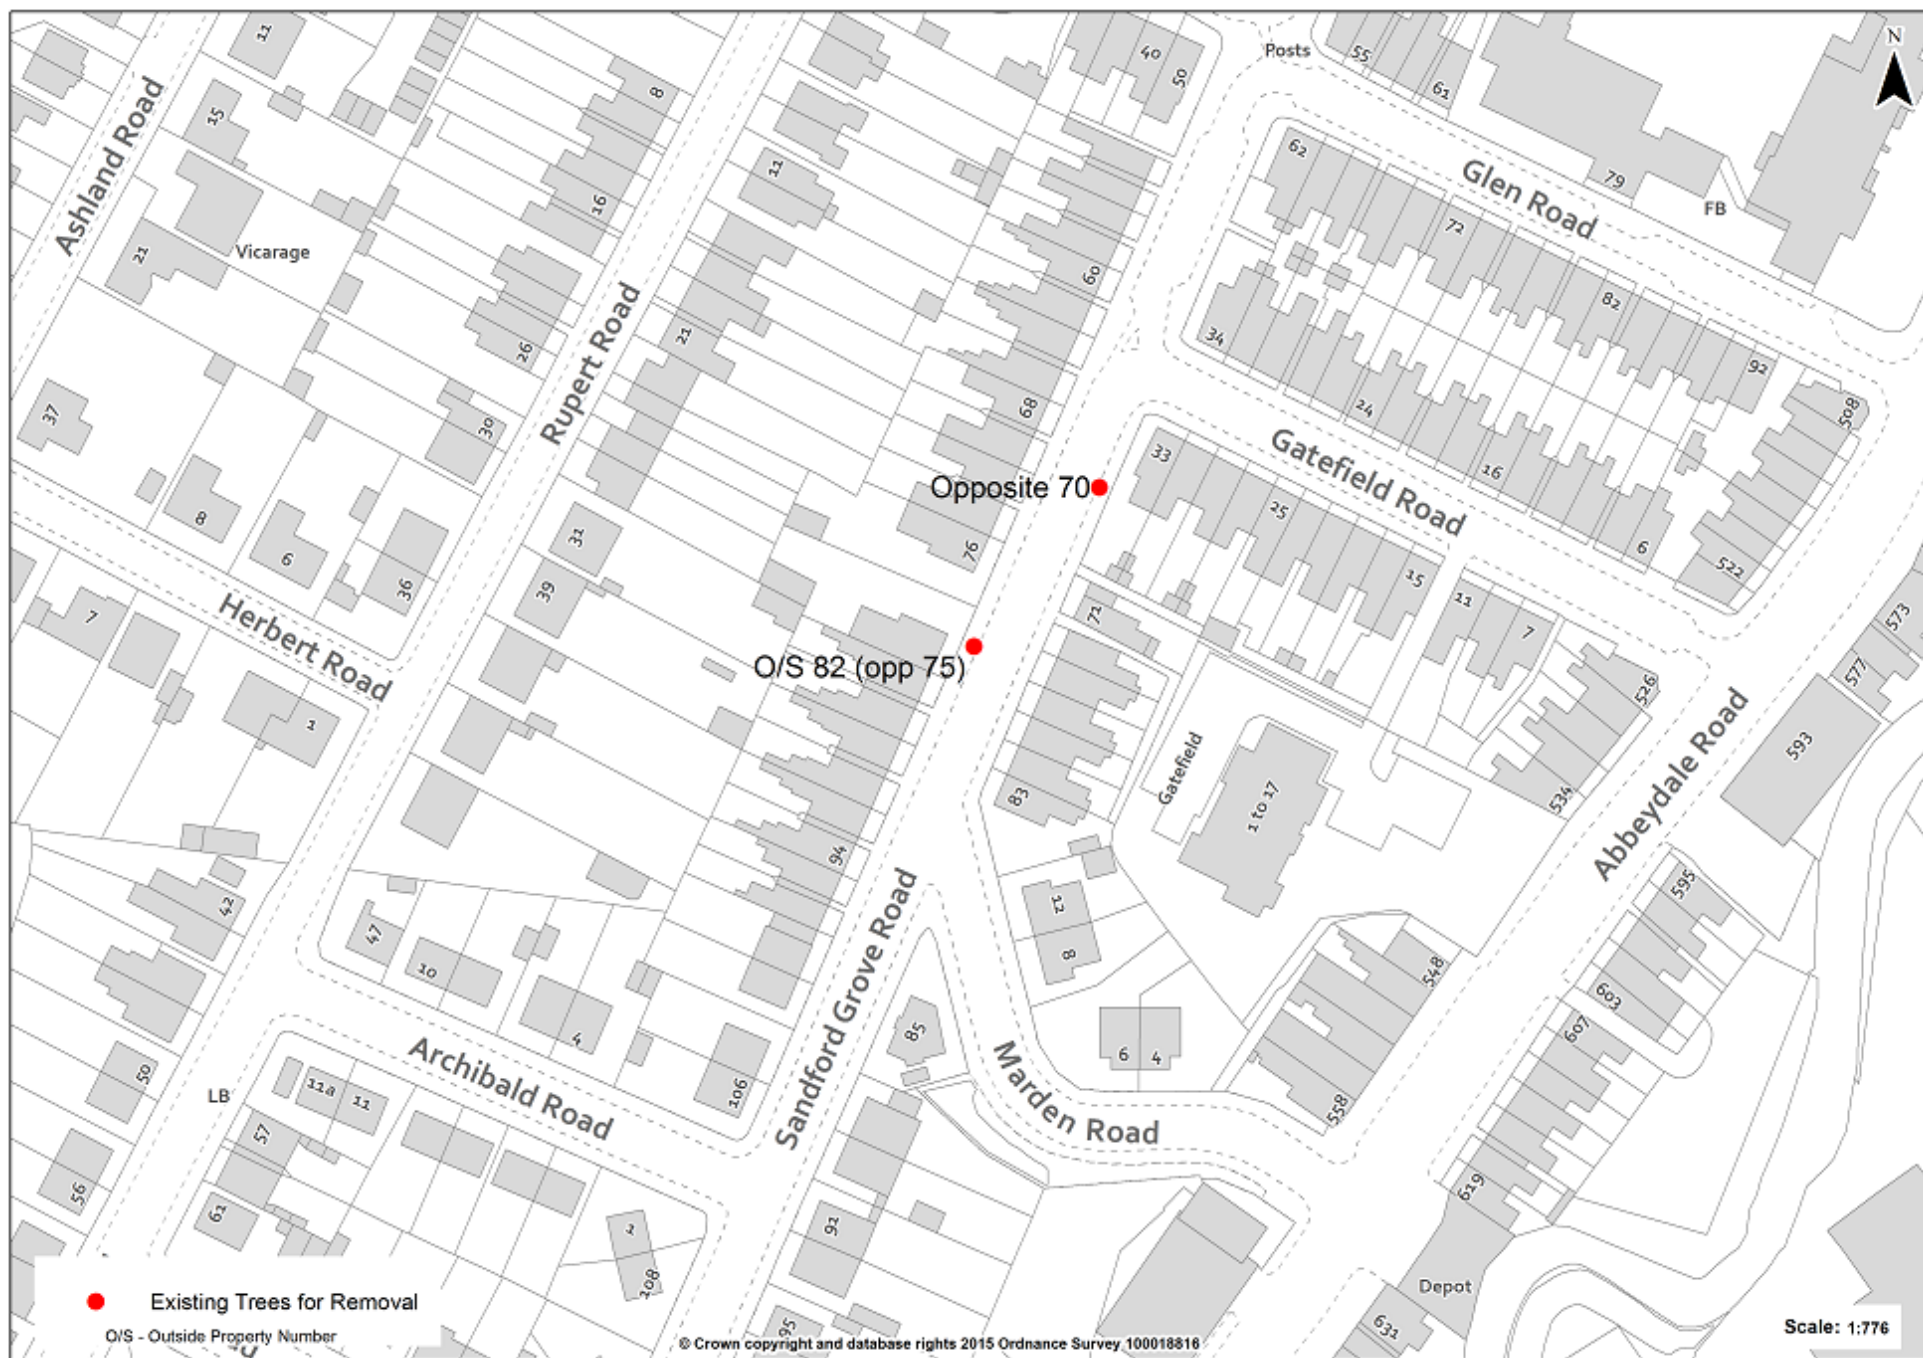
Site Name	Feature Location	6 D's	Reasons	Existing species	Planting notes	Replant species
SANDFORD GROVE ROAD	o/s 82 (opp 75)	Damaging	Extensive kerb disruption - impossible to adequately repair without tree removal	Platanus x hispanica	Plant in new 800mm pit o/s 82 (same as felled tree)	Corylus colurna
SANDFORD GROVE ROAD	opposite 70	Damaging	Kerbstones absent and f/w obstructed, cannot repair to specification without extensive root damage	Platanus x hispanica	Plant in new 800mm pit opposite 70 (same as felled tree)	Corylus colurna
